PROCEEDING INTERNATIONAL CONFERENCE: NOT JUST EIGHT COUNTRIES USE BLACK SEA

22. Using instream pins in order to monitor soil erosion, sediment deposition and water degradation on the river courses of the Black Sea Basin.

Authors: Dr. Koutalakis, P.1, Pagonis, G.1, Kasapidis, I.1, Gkiatas, G.1, Iakovoglou V.1, Zaimes, G.N.1, Drama Greece

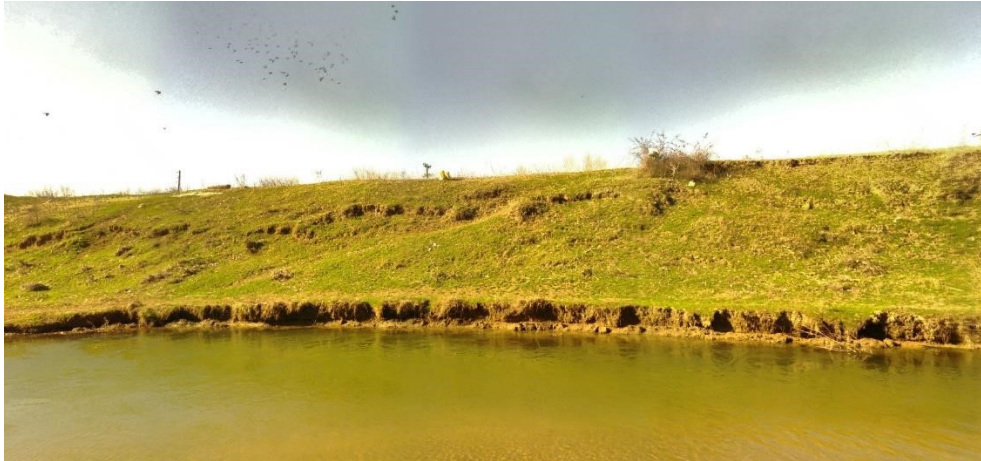
Figure 3. A representative stream bank of the Xiropotamos-Doxato stream where pins were installed.

In erosion pin plot “A” (Table 1) the results showcased that on the bottom part of the streambank (1/3) in all five points was limited with the erosion ranging from 0 to 8 cm. On the upper part of the streambank (2/3), we noticed that it was similar to the bottom part and the maximum erosion was only 8 cm. In erosion pin plot “B” (Table 1), on the bottom part, we noticed that in four of the five pins the erosion was only 3 cm. On the upper part the maximum erosion in four of the five pins was only 5 cm. In contrast, there were two pins one in bottom part and one in upper part that recorded sediment deposition; thus, the minus “-” indicator. In erosion pin plot “C” (Table 1), on the bottom part, we noticed that the erosion was substantially higher (ranged from 28 to 48 cm) than the other two erosion pin plots. Also, there were two (2) pins in the bottom part of the streambank that could not be found (probably lost during high stream flows) corresponding to severe erosion (>50cm). On the upper part, two pins showcased high erosion (ranging from 20 to 40 cm) and the rest three also recorded erosion from 0 to 4 cm. The three erosion pin plots showcased the high spatial variability of streambank erosion even within one erosion plot and among erosion plots.
